# INDOOR AIR QUALITY ASSESSMENT

**Department of Public Works  
Garage Complex  
321 Rear Charger Street  
Revere, Massachusetts**

Prepared by:  
Massachusetts Department of Public Health  
Bureau of Environmental Health  
Indoor Air Quality Program  
August 2016

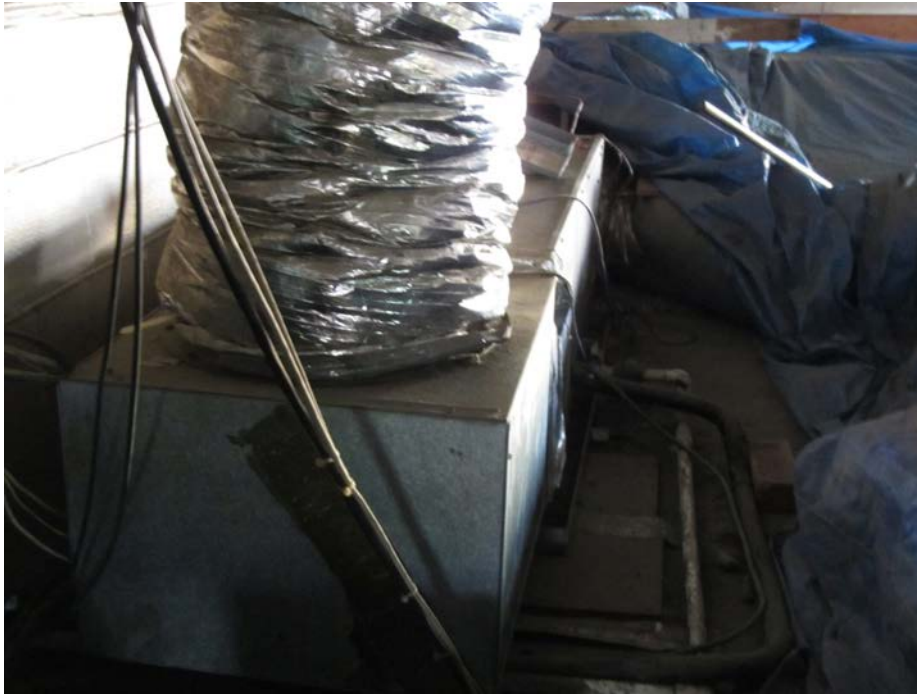
**Picture 1**

Carbon dioxide levels were above 800 ppm in the two main offices indicating inadequate fresh air exchange in these areas (Table 1). The air handling unit (AHU) in the office area is mounted above the ceiling and did not appear to have a fresh air intake, serving only to filter, heat/cool, and recirculate the air (Picture 1). The MDPH typically recommends having mechanical ventilation with a fresh air supply to dilute common indoor air pollutants.

**AHU mounted above office areas does not appear to have fresh air intake**

1. Consider adding specialized vehicle exhaust (direct at tailpipe) if indoor idling is frequently required.
2. If deciding to renovate the DPWG, the building envelope, including the roof, walls, windows and doors should be inspected and repaired/replaced to exclude moisture, and pests.
3. Consider hiring a ventilation contractor to add fresh air capability to the existing AHU which serves the office areas. Also, consider adding an AHU unit with fresh air intake to the left side of the building including the break room/lounge and foreman's office. This will help dilute any common indoor air pollutants and slightly pressurize the offices to further prevent entry of garage pollutants.

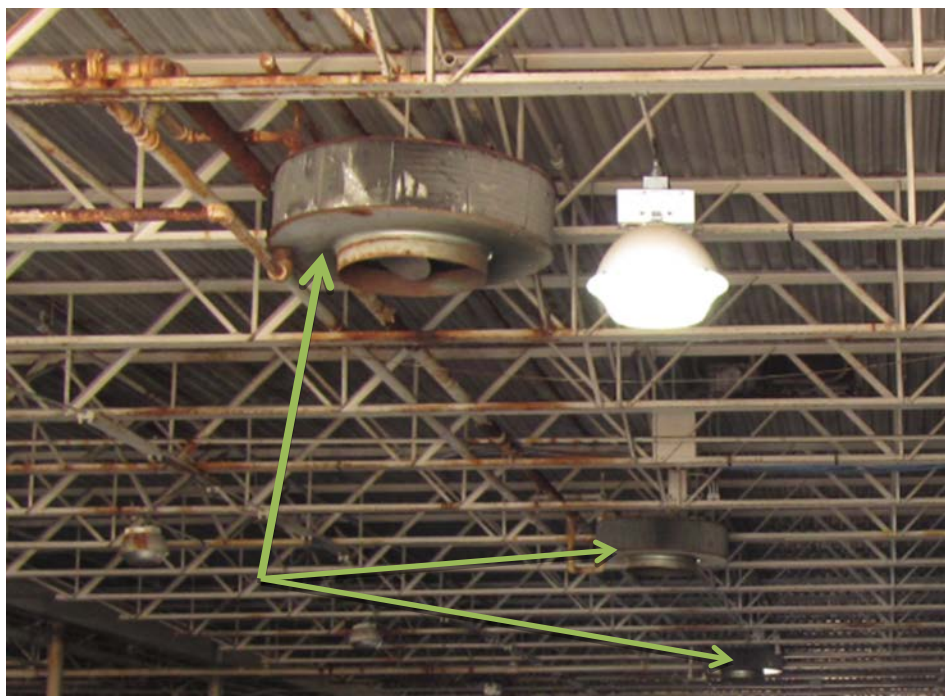
**Picture 2**

Carbon dioxide levels were below 800 ppm in the garage areas, which do not have mechanical ventilation. These areas are heated by large ceiling-mounted gas heaters (Picture 2) which appear to be older and non-vented; they should be inspected regularly to ensure proper functioning and safety. Fresh air is supplied primarily by opening garage doors.

**Gas-fired garage heaters**

4. Consider adding properly placed make-up air louvres especially for use during winter months when doors are normally closed.
5. To ensure proper functioning and safety, older garage heaters should be inspected regularly.

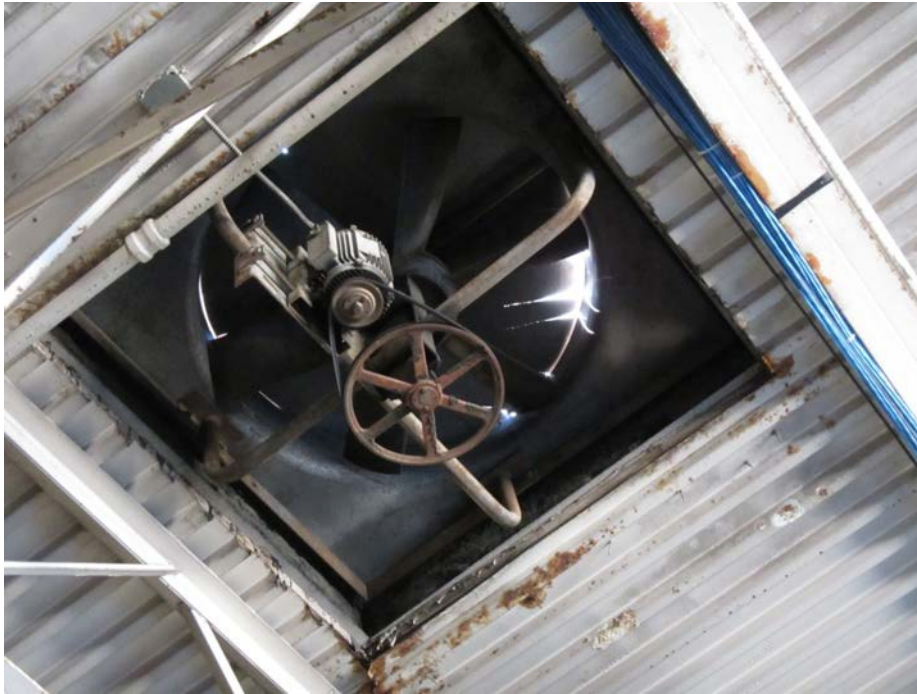
**Picture 3**

The garage building has four ceiling-mounted general exhaust fans (Pictures 3 and 4) that are operated manually (e.g., during vehicle idling or welding). There are no make-up air vents to introduce fresh air during the operation of these exhaust fans. Ideally, a make-up air vent would be sited on the wall opposite the exhaust. Instead, in the main garage, it was reported that DPW staff sometimes open the garage door nearest the exhaust vent. This will provide make-up air but may not be effective at transferring/removing air from other areas of the large garage that are not within the path of cross ventilation.

**Ceiling-mounted general exhaust fan**

2. Refrain from vehicle idling indoors unless absolutely necessary.
3. Utilize existing exhaust ventilation whenever combustion may occur (e.g., vehicle emissions, welding, etc.). Use open doors opposite of vehicle/fan to provide for more effective cross ventilation and controlled make-up air.

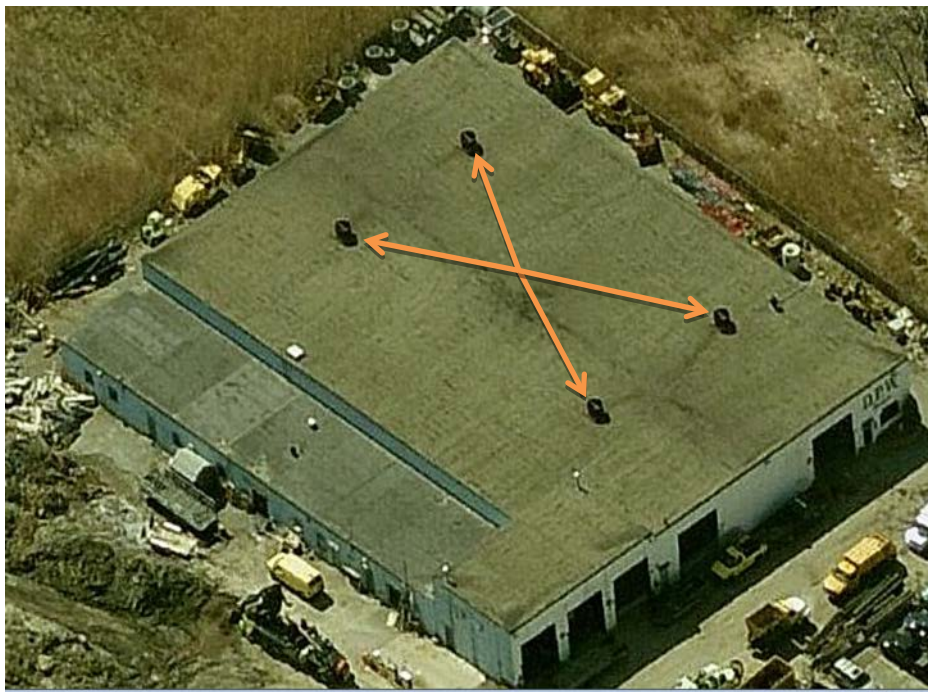
**Picture 4**

**DPW garage roof showing four exhaust vents (arrows)**

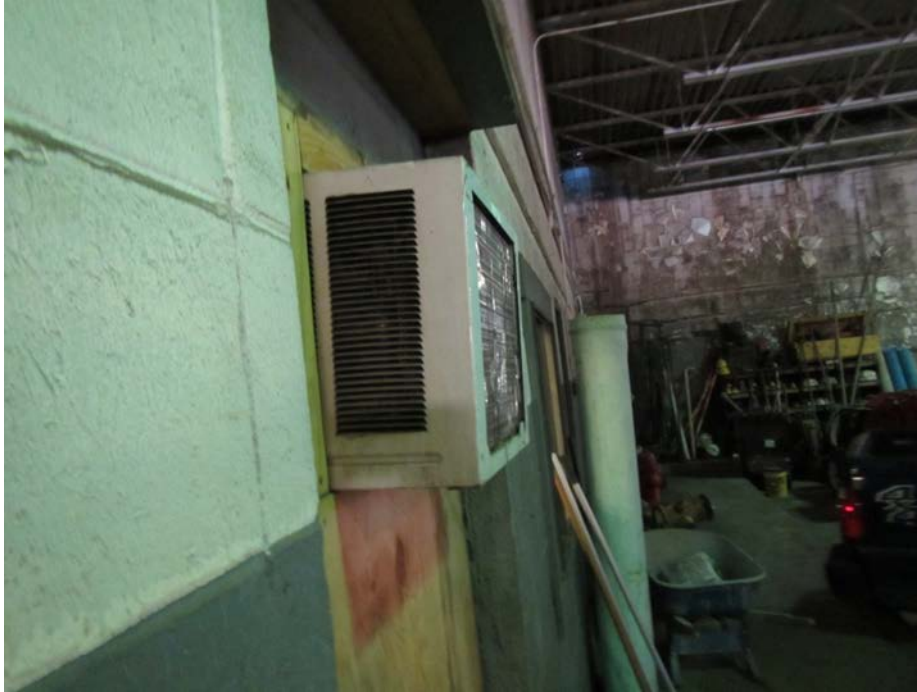
**Picture 5**

Air conditioning (AC) unit filters were noted to be occluded with dust. AC filters/units should be cleaned regularly to avoid aerosolizing particulate matter which could serve as a respiratory irritant or a microbial growth medium. One AC unit draws air from the garage (Picture 5). This unit should be set to recirculate only or relocated to avoid drawing in garage pollutants.

**Air conditioning unit leading to garage**

14. Window AC units could potentially be set to “fan only” to provide a limited amount of fresh air during temperate weather to those areas equipped with these units except for the unit which is directly connected to the garage bays. This unit should be set to recirculate only or removed/relocated to avoid entrainment of garage pollutants.

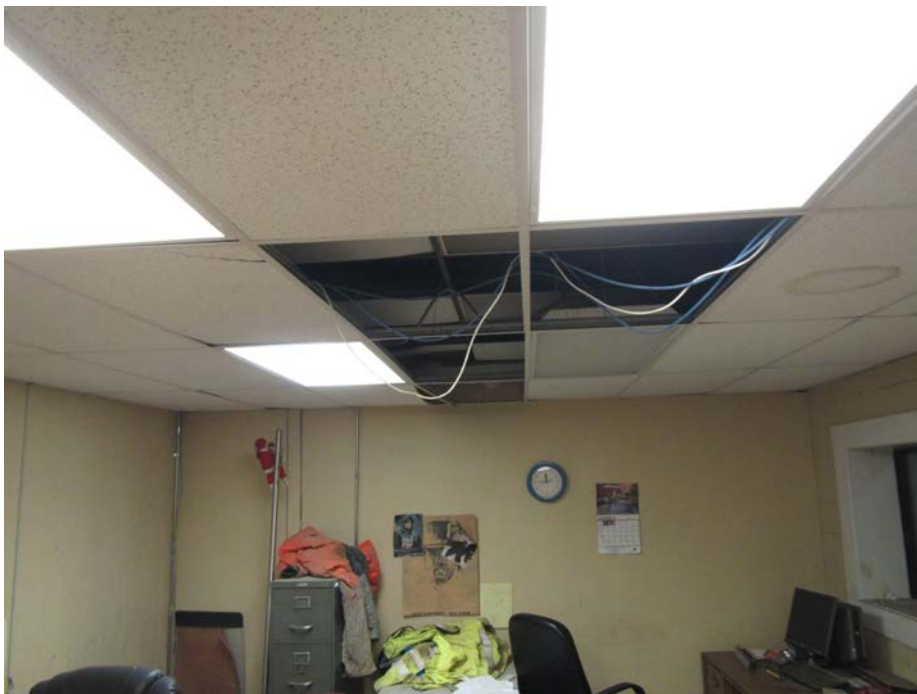
**Picture 6**

Many missing ceiling tiles and gaps around utilities were noted as well (Pictures 6 through 8). Gaps or breaches in the walls and ceilings of occupied areas that lead to the mechanic bays should be properly sealed to avoid the intrusion of particulate matter, odors and water vapor into occupied areas.

**Missing ceiling tiles in DPWG occupied area**

8. Gaps or breaches in the walls and ceilings of occupied areas that lead to the garage bays should be properly sealed to avoid the intrusion of particulate matter, odors and water vapor into occupied areas. Missing ceiling tiles should also be replaced.

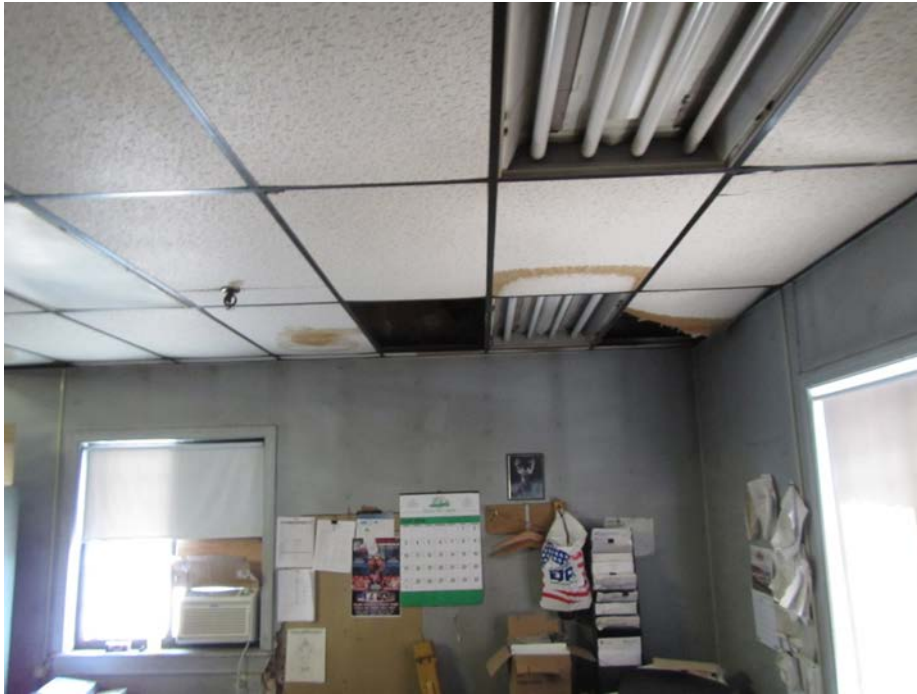
**Picture 7**

**Missing/water-damaged ceiling tiles**

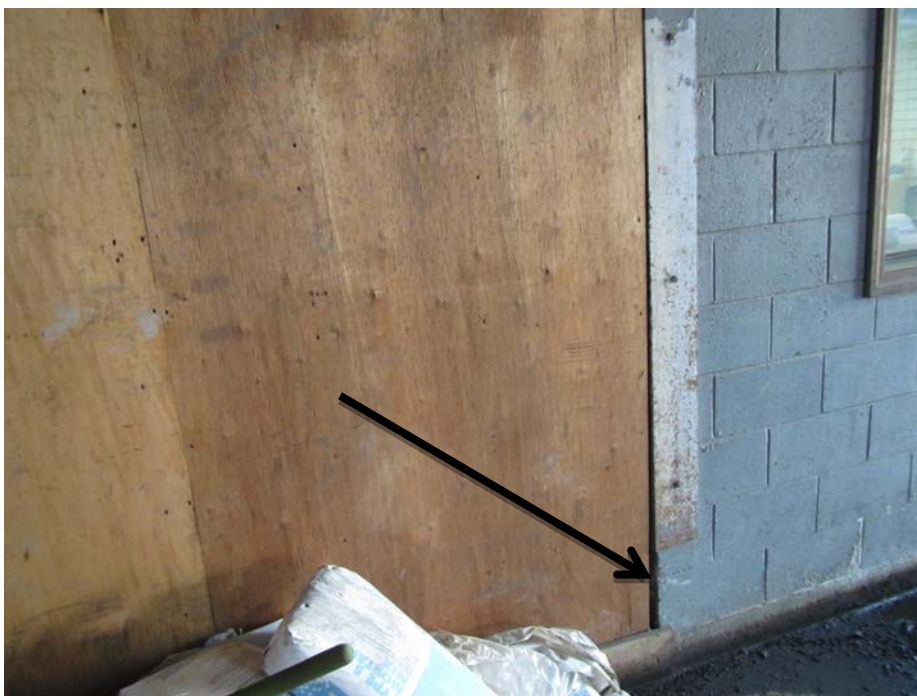
**Picture 8**

**Gaps in wall of storage addition leading to office areas**

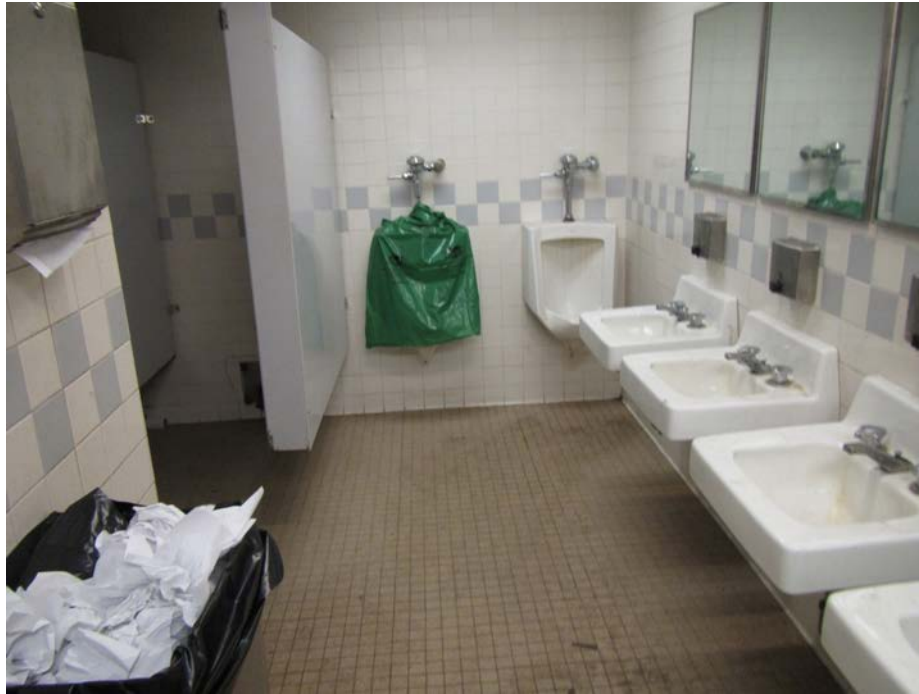
**Picture 9**

The left side bathroom was observed to be in poor condition and had an abandoned urinal (Picture 9). Repairs should be made to plumbing fixtures or they should be properly capped to avoid the trap from drying out and serving as a pathway for sewer gases into the DPWG.

**Bathroom with broken urinal**

11. Make necessary repairs to any plumbing fixtures in bathrooms or cap and properly abandon them to avoid dry drain traps and possible sewer odors in the DPWG.

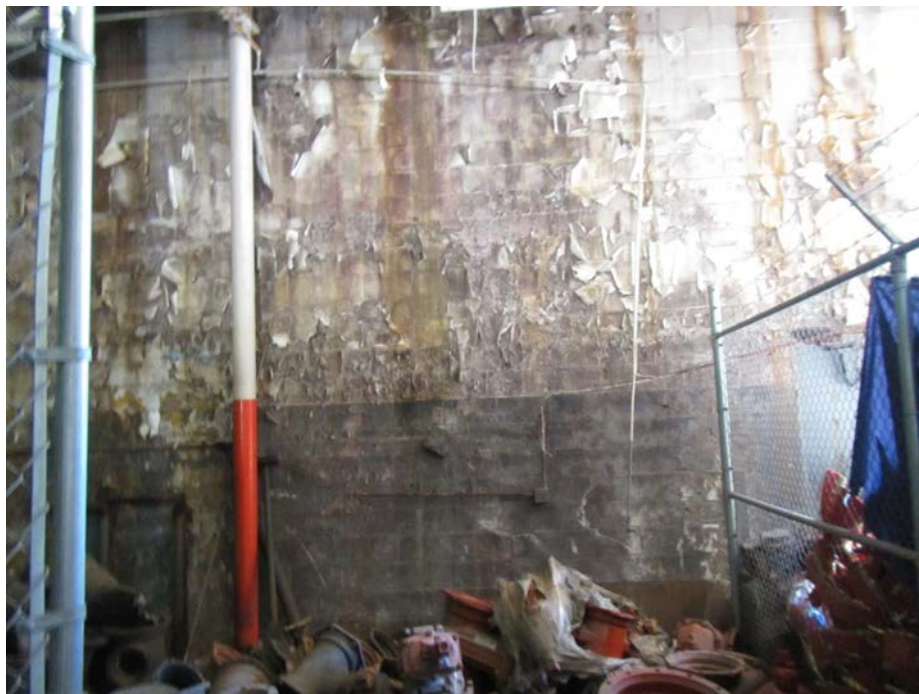
**Picture 10**

- DPW garages are normally exposed to moisture from vehicles and activities;
- Most building materials at the DPWG are made from materials that are not conducive to mold growth (e.g., concrete walls and flooring). However, debris and paint on these concrete walls may support microbial growth (Pictures 10 and 11);

**Concrete block wall with peeling paint, debris, and possible microbial growth**

10. Clean debris, loose paint, and likely microbial growth on rear cinderblock wall. Lead-safe practices may be necessary due to the age of the building.

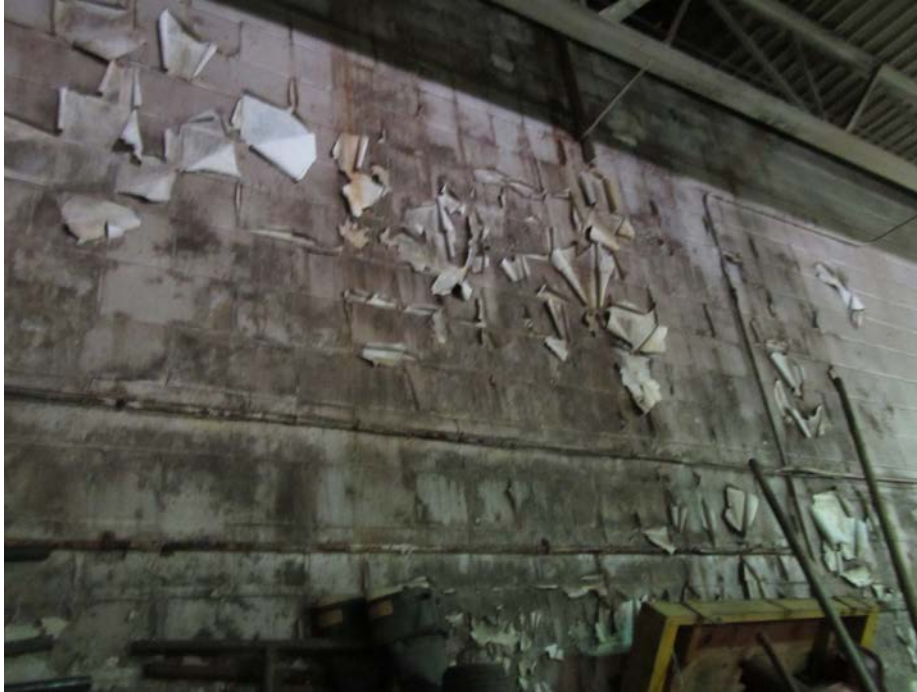
**Picture 11**

**Concrete block with peeling paint, debris, and possible microbial growth**

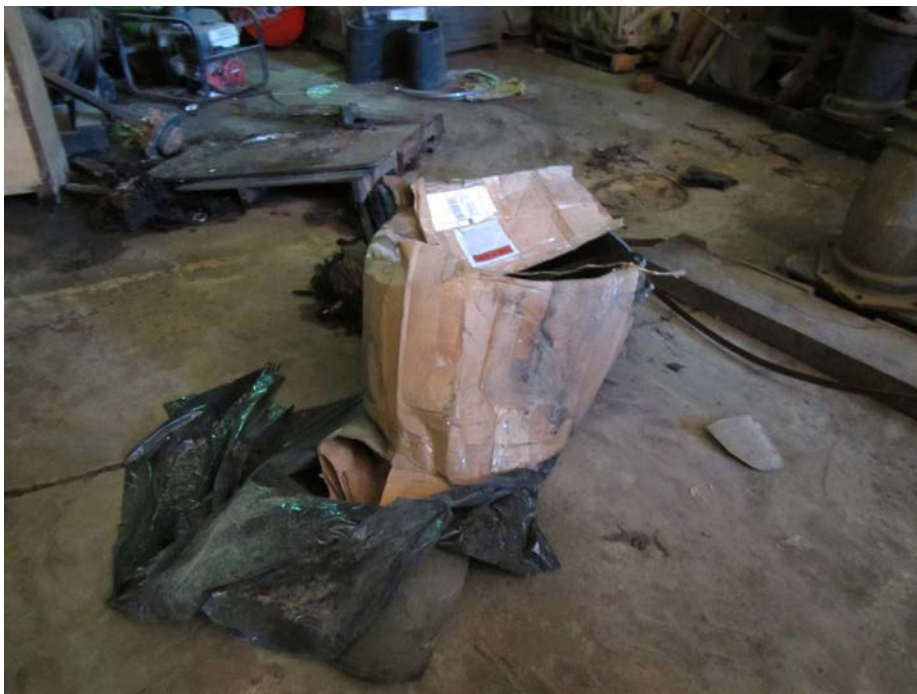
**Picture 12**

All of the above are sources of water exposure at the DPWG. Cardboard boxes and other porous materials were observed directly on the floor of the DPWG (Picture 12). These should be stored on shelves or otherwise elevated to prevent wetting from garage activities or condensation, which can lead to water damage and mold growth.

**Water-damaged cardboard stored directly on garage floor**

15. Do not store porous materials (e.g., cardboard boxes) directly on floors; elevate/place on pallets or shelving to prevent water damage and mold growth.

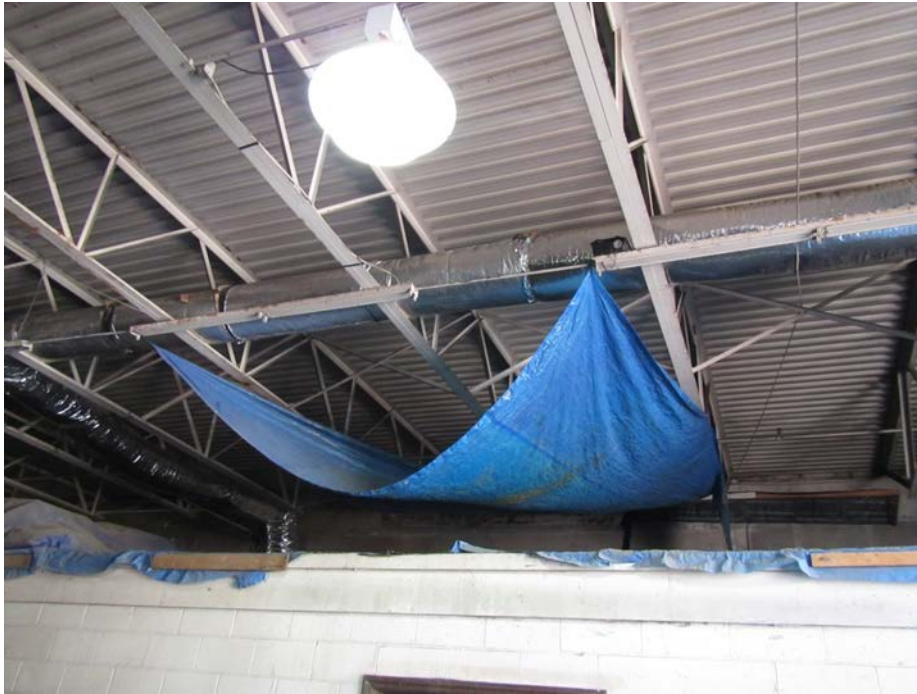
**Picture 13**

- DPW staff reported that the garage roof has had chronic water leaks for many years;
- BEH/IAQ staff noted tarps being used to shelter the office area from leaks (Picture 13);

**Tarps being used to shed leaking water away from office area below**

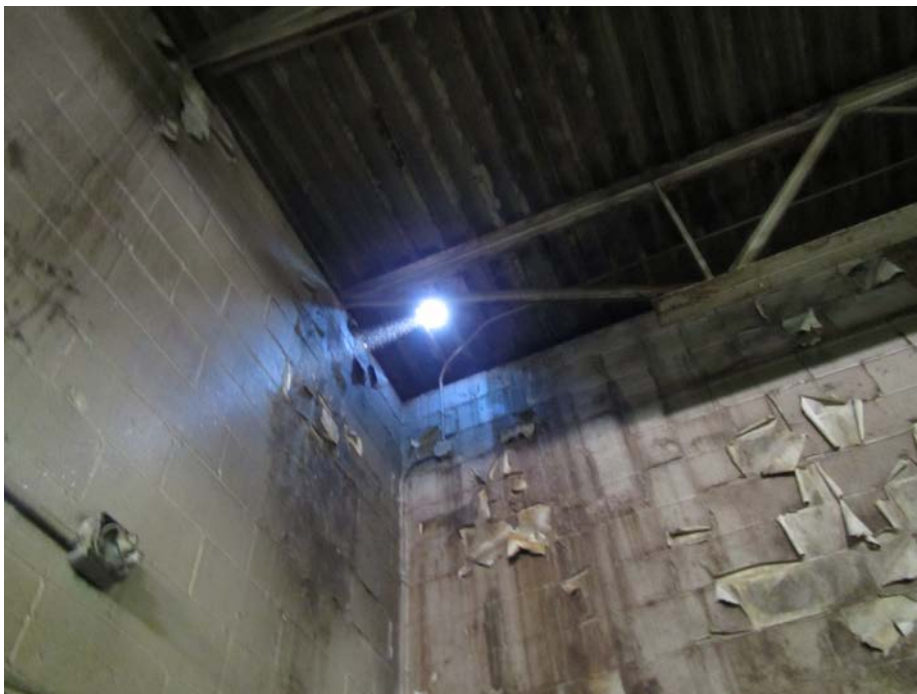
**Picture 14**

- The building envelope was noted to be in poor condition with holes and breaches in the roof, concrete block walls, and doors (Pictures 14 through 16);

**Hole in roof showing penetrating daylight and chronic water damage**

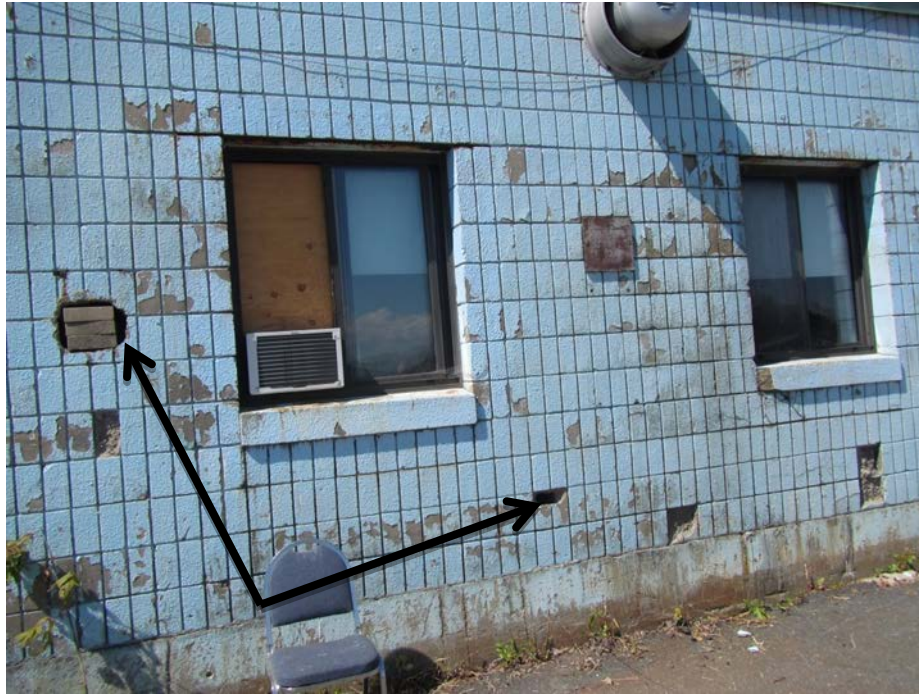
**Picture 15**

**Deteriorating exterior walls of the DPW garage showing open holes**

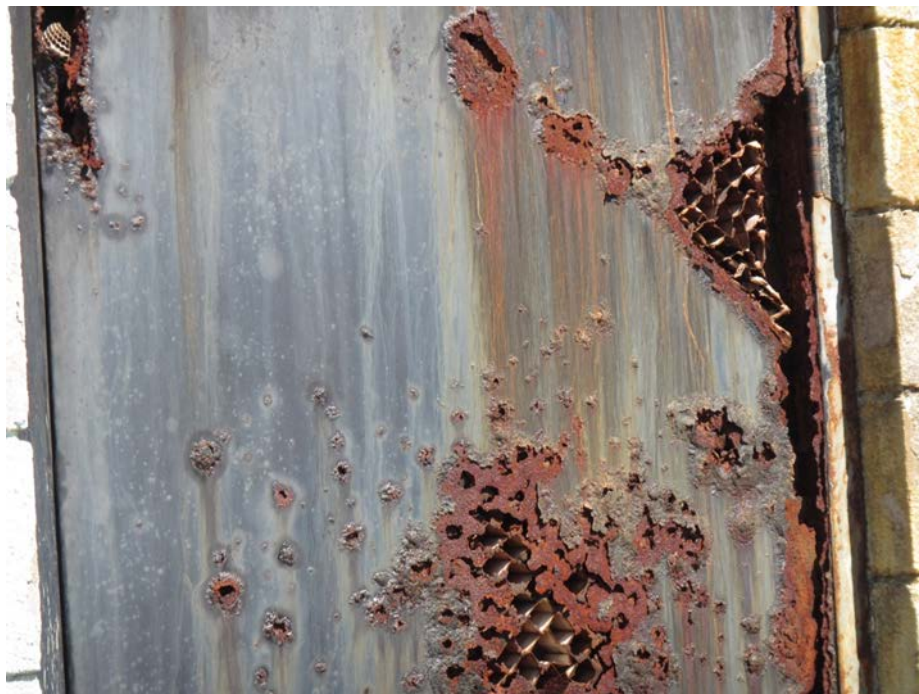
**Picture 16**

**Badly corroded rear exterior door**

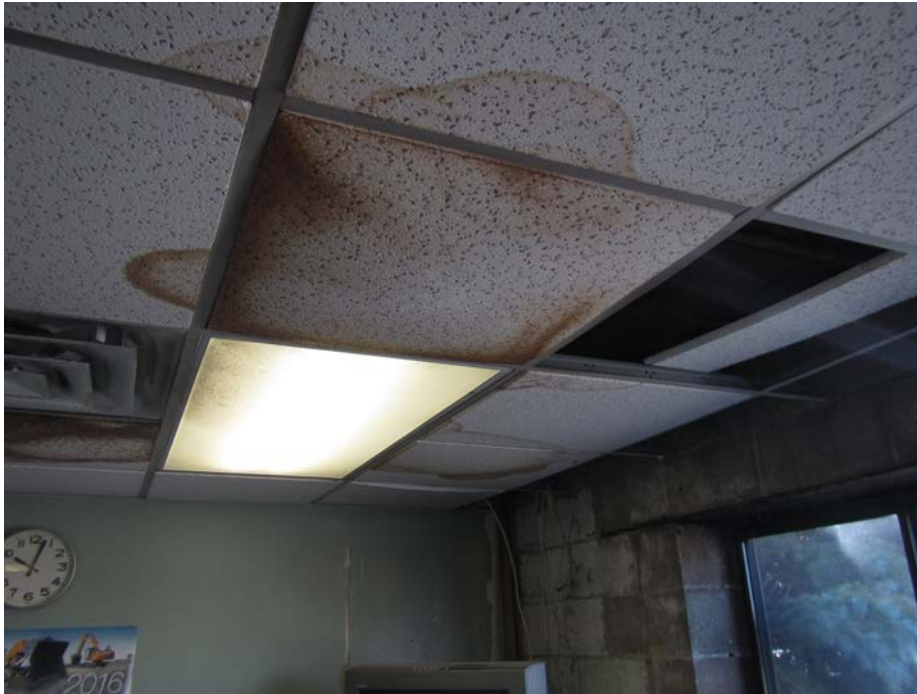
**Picture 17**

- Numerous water-damaged ceiling tiles and other porous items were noted in occupied areas (Pictures 17 through 19);
- Standing water was observed in the garage in multiple areas due to a recent rain event (Picture 20);

**Water-damaged (and missing) ceiling tiles in DPW office**

9. Water-damaged ceiling tiles, insulation or other porous items (carpeting, gypsum wall board, paper/boxes, etc.) should be removed in a manner consistent with recommendations found in “Mold Remediation in Schools and Commercial Buildings” published by the US Environmental Protection Agency (US EPA, 2001).

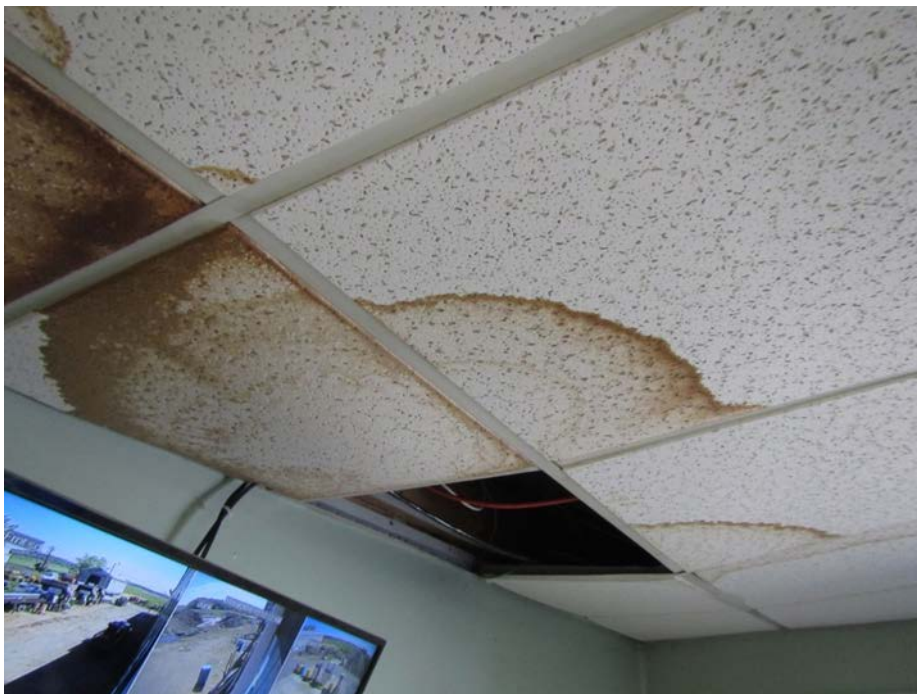
**Picture 18**

**Water-damaged (and missing) ceiling tiles in DPW office**

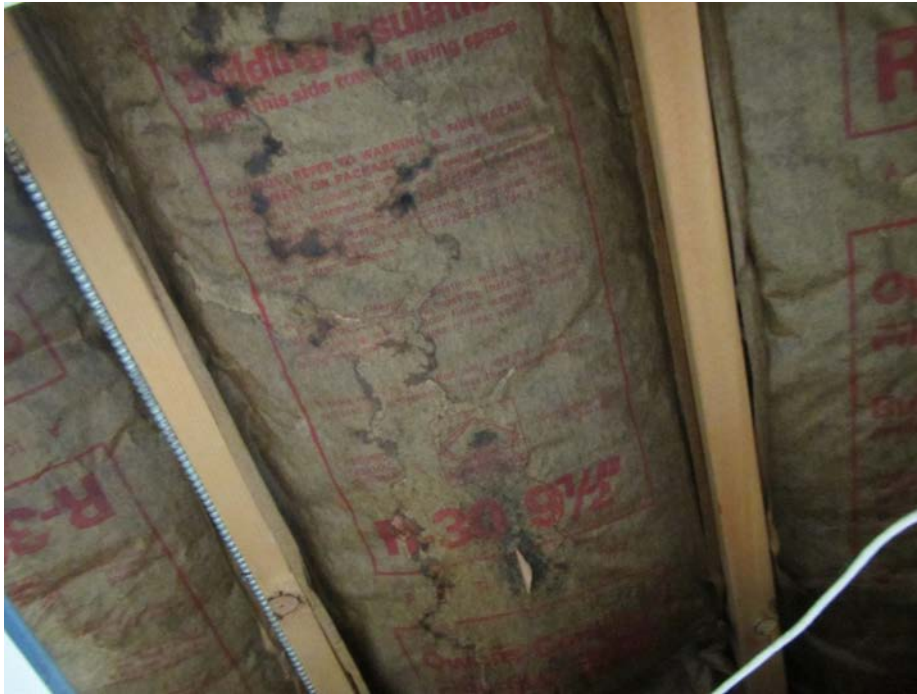
**Picture 19**

**Water-damaged paper-backed insulation in DPW office**

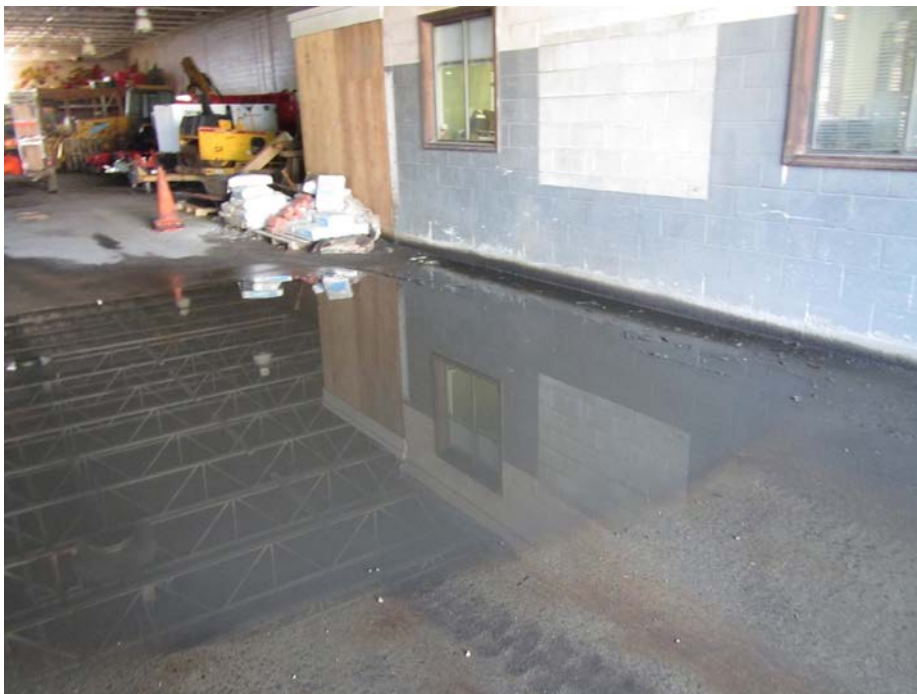
**Picture 20**

**Standing water outside of DPW office area**

7. Regularly remove standing water from the DPWG with vacuum truck or other effective method.

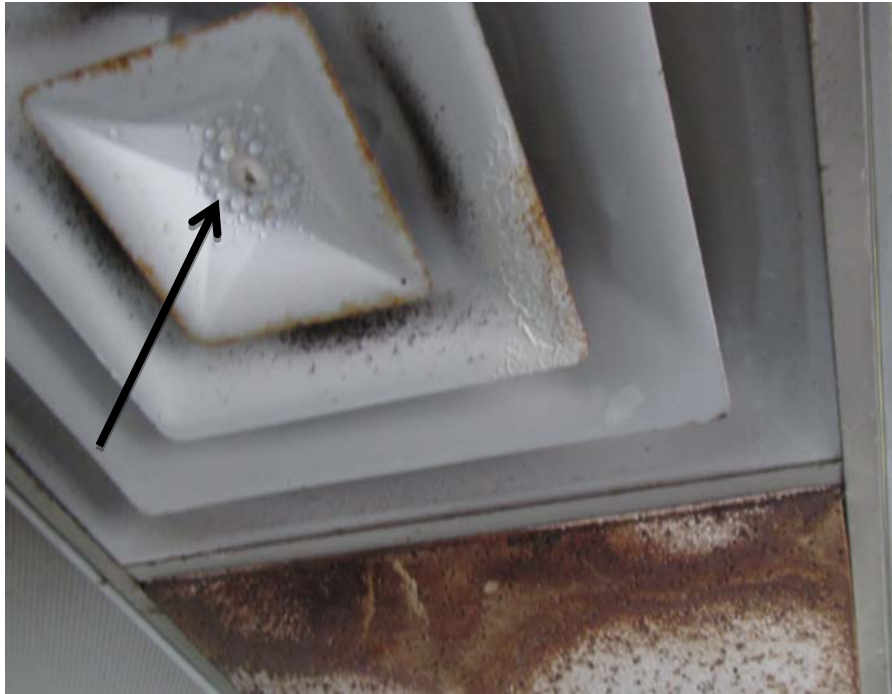
**Picture 21**

- DPW staff reported that DEP had previously ordered that the floor drains be sealed to prevent pollution to the nearby marsh;
- Condensation was observed on supply vents in office areas. This is evidence that warm, moist air is entering office spaces while the air conditioning is in use (Pictures 21 and 22). Condensation may accumulate and chronically moisten porous items within the office area.

**Condensation on supply vent (also note badly water-damaged ceiling tile)**

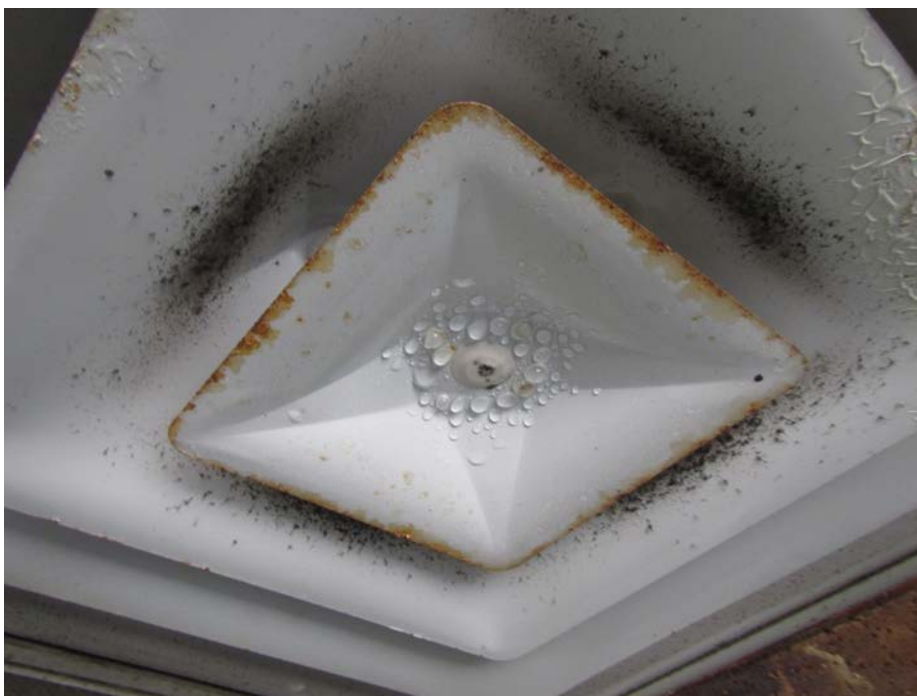
**Picture 22**

**Close up of condensation droplets on supply vent**
